Appendix F1 – Assessment of Controls (Watershed Restoration Assessment)

WHEEL CREEK WATER CHEMISTRY MONITORING YEAR 12 REPORT

Harford County
Department of Public Works
Watershed Protection and Restoration
212 South Bond Street
Bel Air, Maryland 21014

Final, December 22, 2022

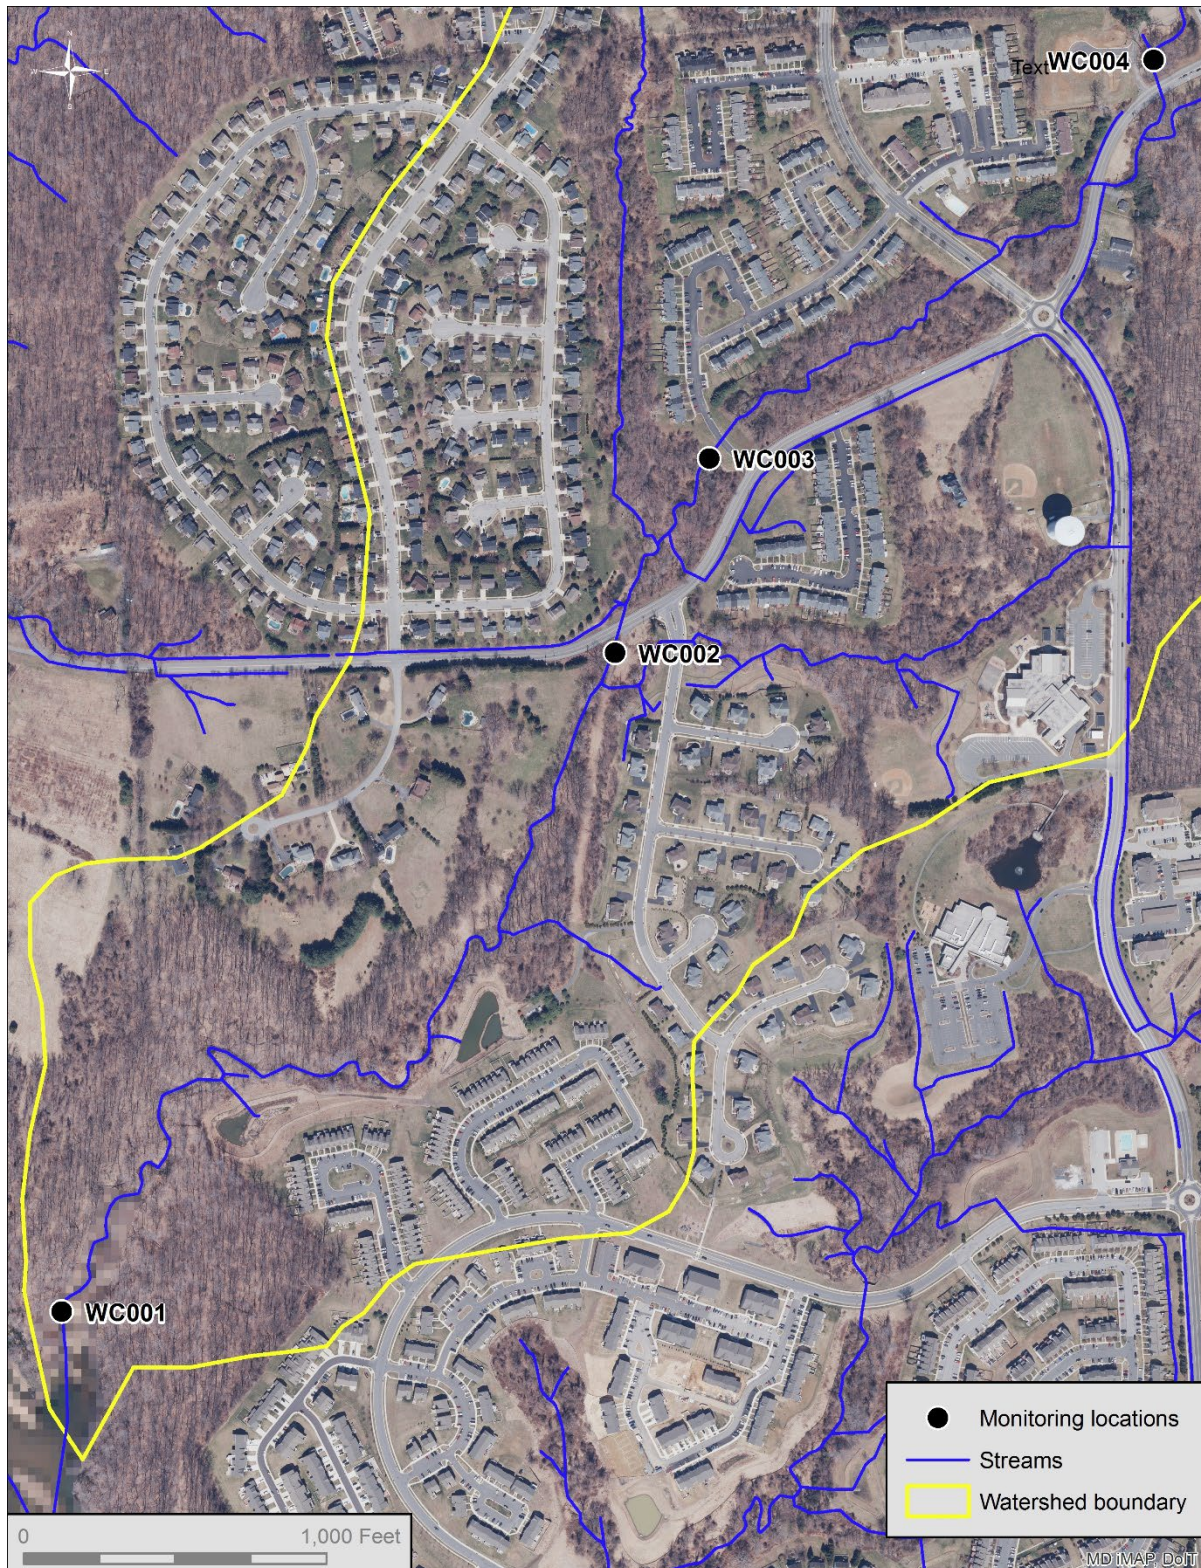
Figure 2-1. Wheel Creek Watershed long-term water chemistry monitoring stations

Three long-term automated water chemistry sampling and flow logging stations were established at Stations WC002, WC003, and WC004 (Figure 2-1). Station WC004 is located on the middle branch, immediately downstream of the stormwater retrofit at Festival Shopping Center (Point C). Stations WC003 and WC004 bracket completed stormwater retrofits at Pond D and Pond E along the middle branch. Station WC002 is located on the mainstem and water chemistry data collected there will provide an overall assessment of the benefits of retrofit and restoration projects in upstream tributaries (Figure 2-2). Baseflow monitoring took place at three stations along the Wheel Creek main stem and tributaries (WC002, WC003, and WC004).
